Manhole Inspection Summary

Manhole # S41QQ_009MH

Insp Date: **4/6/07 12:22 PM**

Location Address: **900 25TH ST**

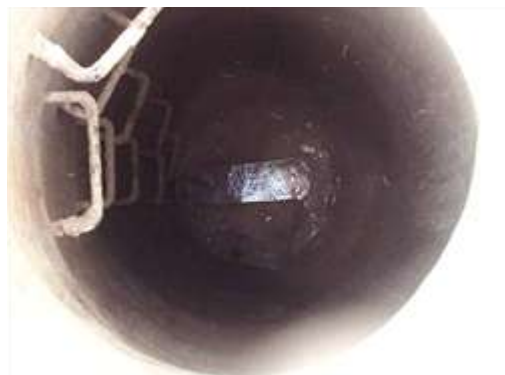
Top View

☒ **Debris** (not Condition related)

Bench debris.

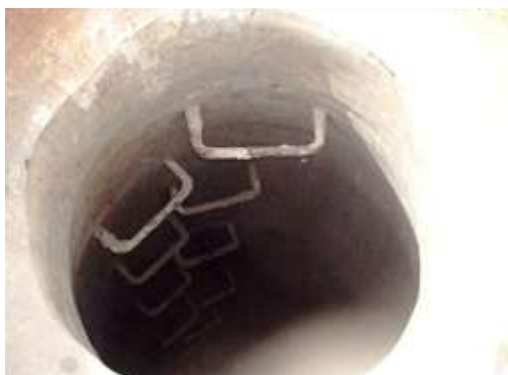
Defect

☒ **Leaks**

Infiltration: ☐ None ☒ **Joint** ☐ Cracks ☐ Mortar ☐ Roots ☒ **Wall**

Frame leaks. Corbel infiltration.

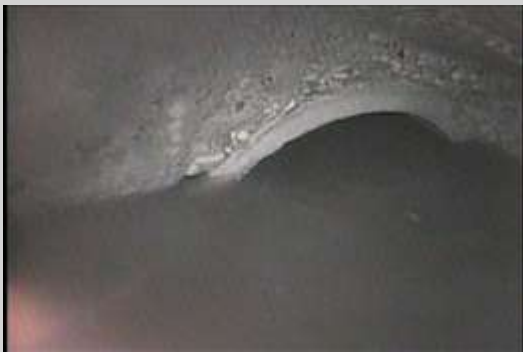
24 in. Circular Gravity Sewer Pipe Out @ 12 O'Clock

Pipe Material: **PVC** ☐ Pipe Lined

Invert Depth: **18.24** (ft.) Flow Characteristics: **Slow**

Deposits: ☒ None ☐ Mud ☐ Sludge ☐ Debris ☐ Grease

Infiltration: **None** Pipe Seal Cond: **Unknown**

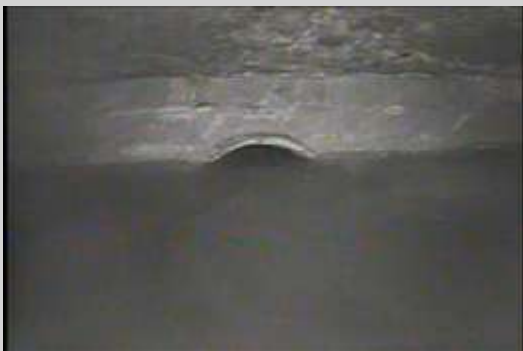
8 in. Circular Gravity Sewer Pipe In @ 3 O'Clock

Pipe Material: **Clay** ☐ Pipe Lined

Invert Depth: **18.01** (ft.) Flow Characteristics: **None**

Infiltration: **None** Pipe Seal Cond: **Unknown**

Connects To: **Dead End**

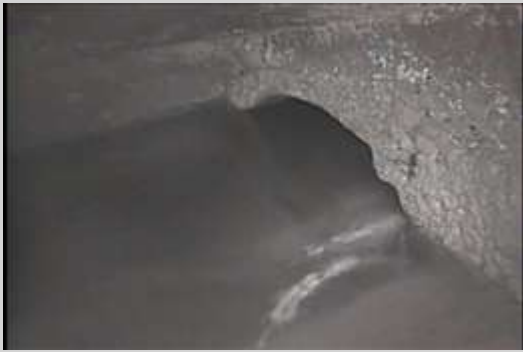
24 in. Circular Gravity Sewer

Pipe Material: **PVC**

Invert Depth: **18.08** (ft.) Flow Characteristics: **Slow**

Infiltration: **None**

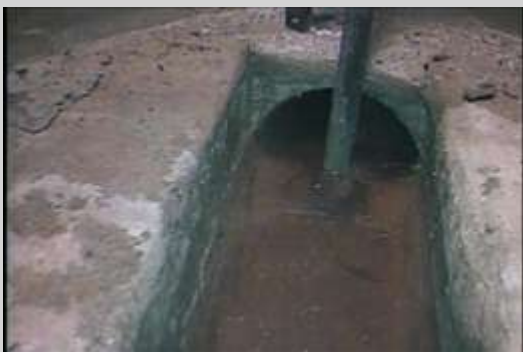
8 in. Circular Gravity Sewer

Pipe Material: **Clay**

Invert Depth: **17.97** (ft.) Flow Characteristics: **Slow**

Infiltration: **None**
